Big Meadows Project - A Brief Overview

Bobby Kamansky, Project Consultant, Sierra Nevada Conservancy.

Summarized from Program Report, submitted to the Sierra Nevada Conservancy, August, 2009.

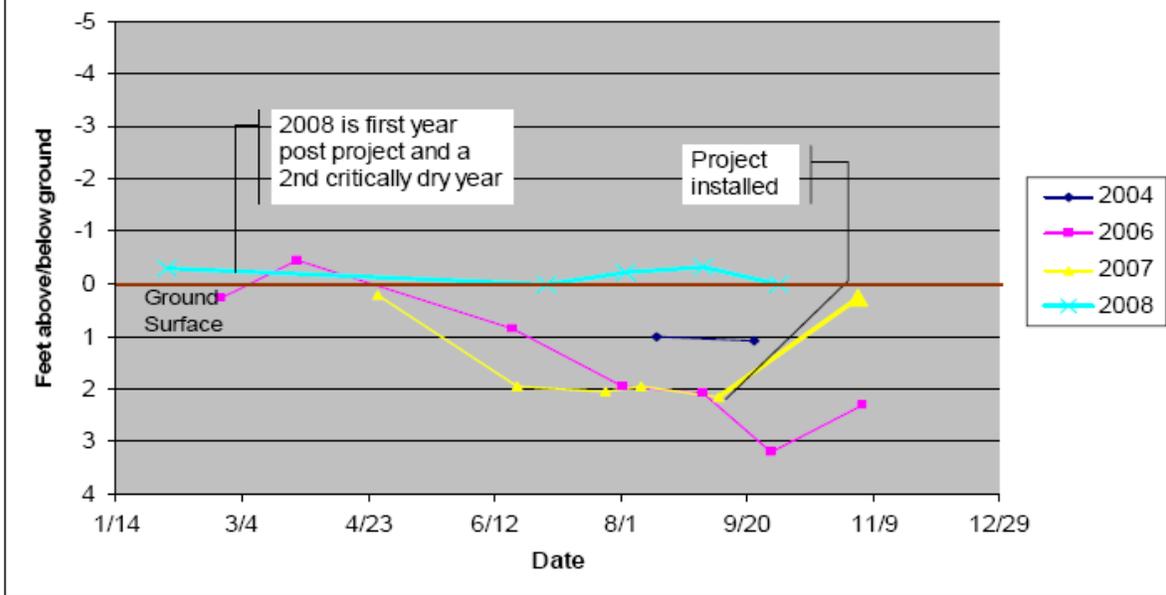
Lower Meadow Peizometer (Measures Depth of Ground Water Table)

Initial results suggest that employing this method in such a damaged ecosystem as this was effective in reducing erosion, improving habitat for key species such as cold water fishes and macroinvertebrates as well as wetland plants. In addition, the meadow's groundwater rose significantly after restoration (see figures) and the meadow returned to a perennially wet state, slowing flows, but retaining cold water conditions and improving wetland habitat for native species.

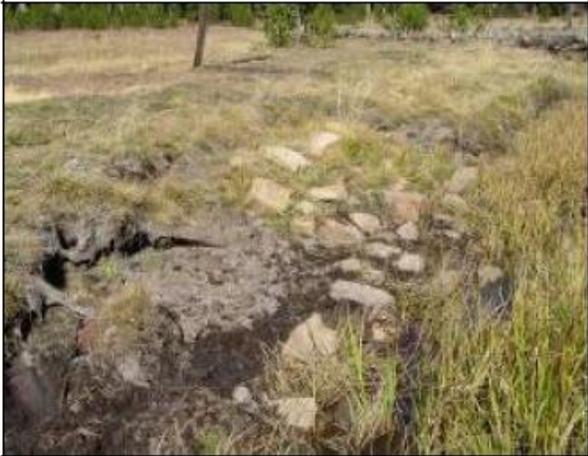
Lower reach, eroded & trampled banks, failed gabion.

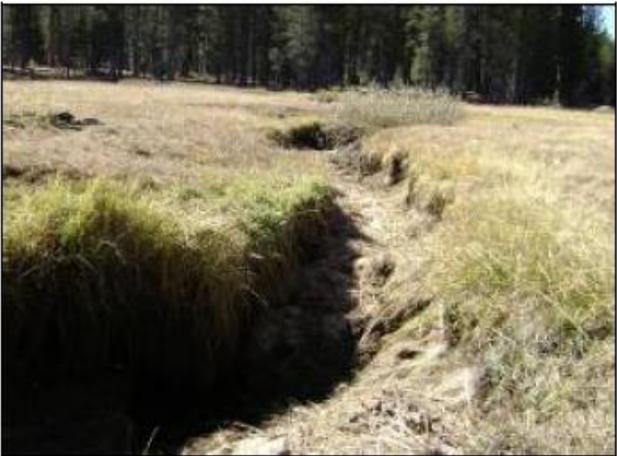
Upper reach, eroded banks

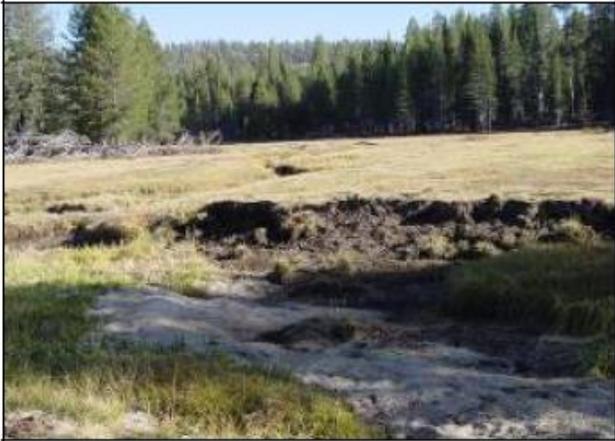
Upper reach, eroded banks

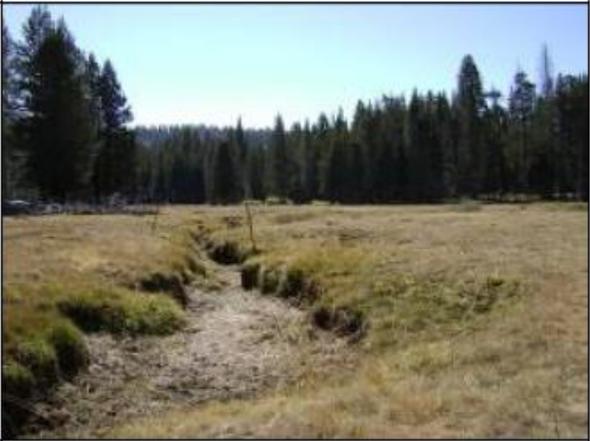
Upper Peizometer Looking upstream

One year post project
